Phase I Environmental Site Assessment

MLK / 9th Avenue East Vacant Parcels

214-228 East 9th Avenue

April 2012

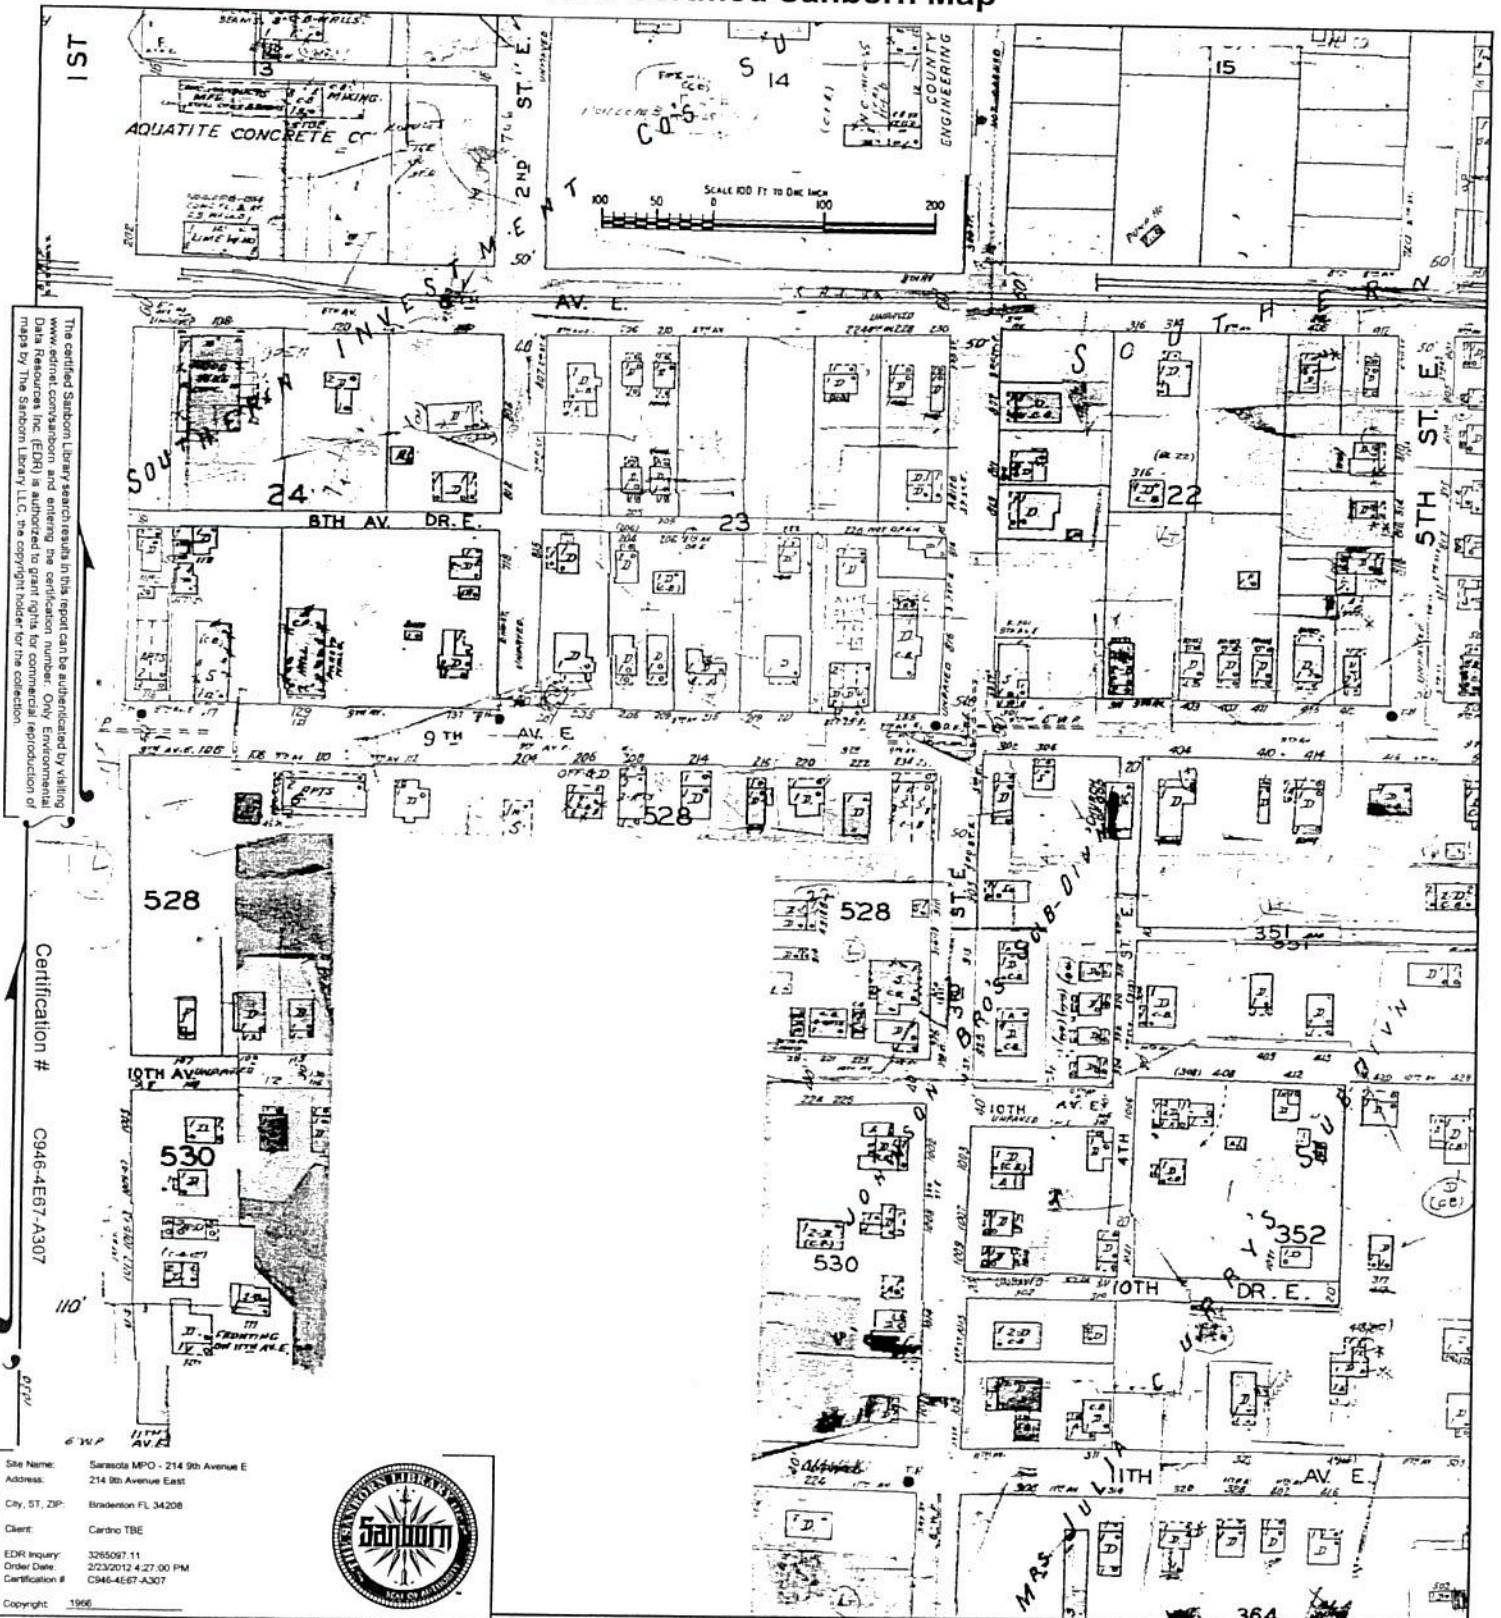
1966 Certified Sanborn Map

Sanborn Fire Insurance Map Information:	
Years	Observations
1929	The subject site is depicted with residential dwellings.
1948, 1966	In addition to the residential dwellings, one structure located near the northeast corner of the site is depicted as a commercial (store) structure.
Aerial Photograph Review Results:	
1951 - 2003	No features observed on aerial photos refute the findings of the historical directories or Sanborn Maps.

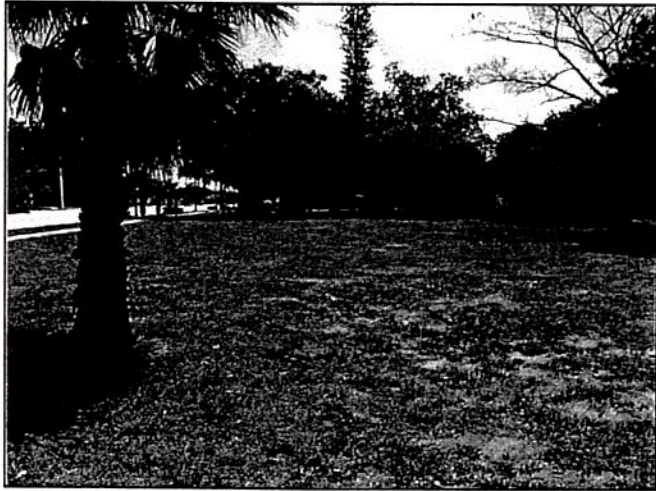
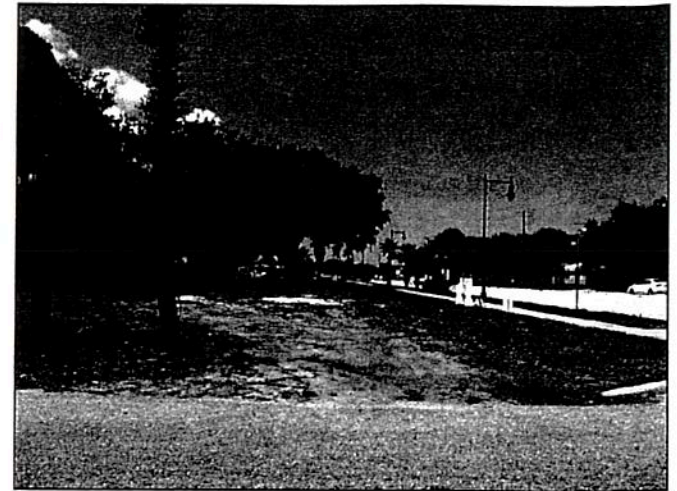
- The site was an undeveloped, vacant property at the time of the site visit.
- Based on the observed topography, surface drainage is anticipated to flow primarily toward the adjacent roadways (9th Avenue and 3rd Street) and associated subsurface drainage systems.
- Vehicular access to the subject site is possible from both adjacent roadways.
- No indications of wells (irrigation or drinking water) were observed on-site.
- No surface impacts related to PCB-containing electrical equipment were observed on-site.

*Left and Right: Views of
subject site.*

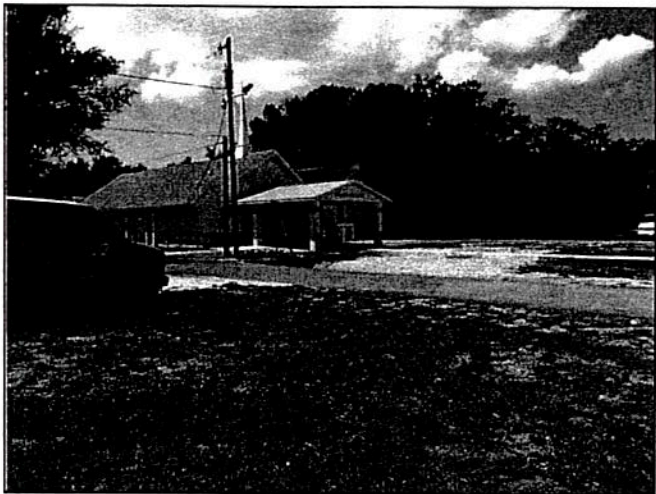
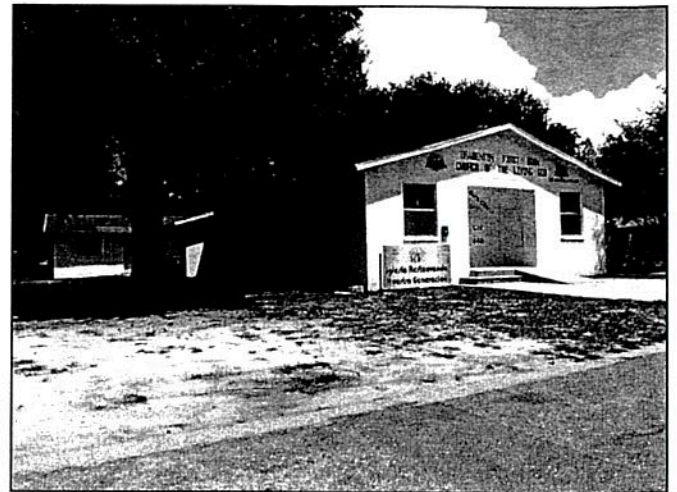
*Left and Right: Views of
contiguously adjacent non-
residential properties
(churches).*
